## Design and Performance of a Channel Reconstruction Project in a Coastal California Gravel-Bed Stream

**ABSTRACT** / A 0.9 km-reach of Uvas Creek, California, was reconstructed as a sinuous, meandering channel in November 1995. In February 1996, this new channel washed out. We reviewed project documents to determine the basis for the project design and conducted our own historical geomorphological study to understand the processes operating in the catchment and project reach. The project was de-

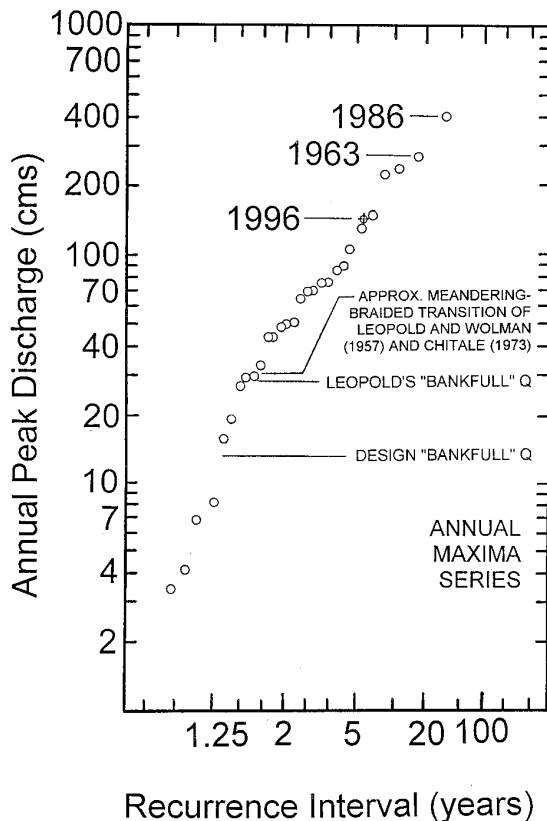
Figure 4. Empirical flood-frequency analysis (annual maxima) for the gauge, Uvas Creek near Gilroy. The period of record was 1959–1992, but there were no data for 1977 and 1988, and we did not plot the lowest two annual peaks of  $0.04 \text{ m}^3 \text{ sec}^{-1}$  in 1976 and  $0.08 \text{ m}^3 \text{ sec}^{-1}$  in 1961 to simplify scaling the plot. Also shown for comparison is the peak flow in 1996, estimated at  $140 \text{ m}^3 \text{ sec}^{-1}$  by the Santa Clara Valley Water District. (Source: published records of the US Geological Survey.)

District at  $140 \text{ m}^3 \text{ sec}^{-1}$ ; this flow has a return period of 5–6 years on our flood frequency analysis (Figure 4). Our analysis also indicated that  $Q_{1.25}$  is  $16 \text{ m}^3 \text{ sec}^{-1}$ , not the  $12.6 \text{ m}^3 \text{ sec}^{-1}$  indicated in the Project Plan. Leopold (unpublished data in the Water Resources Center Archives, University of California, Berkeley) listed bankfull discharge as  $28.3 \text{ m}^3 \text{ sec}^{-1}$  for the same gauge, defining bankfull discharge as the flow with a 1.5-year return period ( $Q_{1.5}$ ).

Our flood frequency analysis and the unpublished data of Leopold (both reported above) suggest that the  $Q_{1.25}$  given in the Project Plan was too low. This may have contributed to the project failure. However, the Project Plan’s assumption that a channel designed with bankfull flow equal to  $Q_{1.25}$  would provide stability is questionable because it does not consider the site’s geomorphic context. The notion of the 1.5-year flow as bankfull or channel-forming discharge is based on research in humid-climate and snowmelt streams (Wolman and Leopold 1957). However, the return periods associated with the bankfull form actually observed in nature vary widely (Williams 1978). In semi-arid settings, with their episodic flow regimes, channels are more influenced by less frequent flows (Wolman and Gerson 1978, Hecht 1994). Typical of streams in the Coast Ranges of central California, Uvas Creek can be considered an episodic channel, as evidenced by its extreme range of discharge.

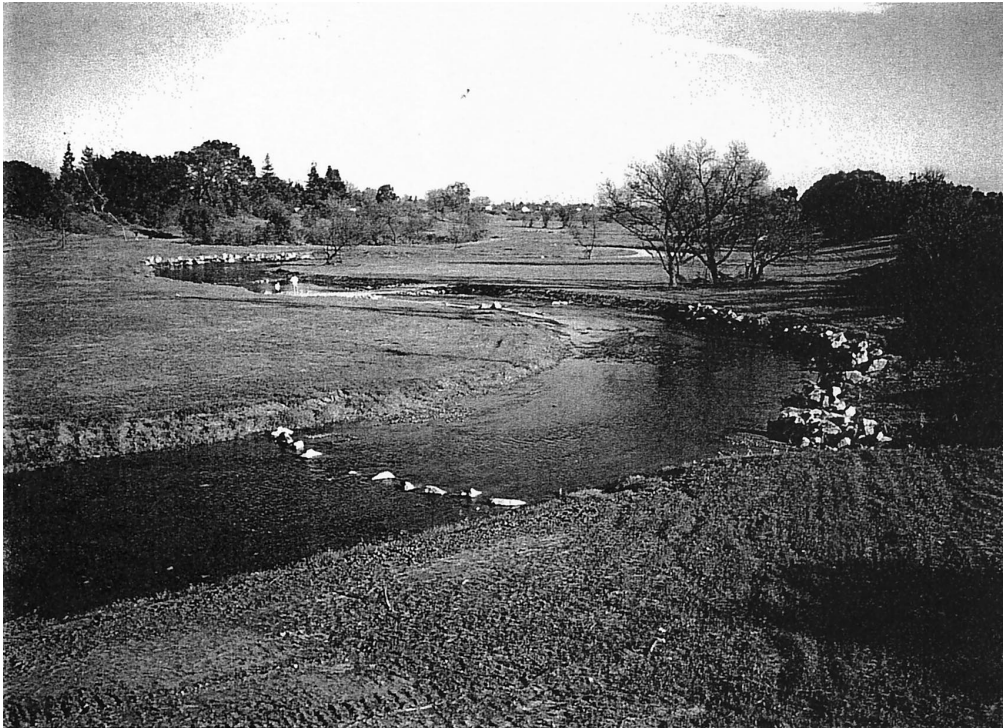
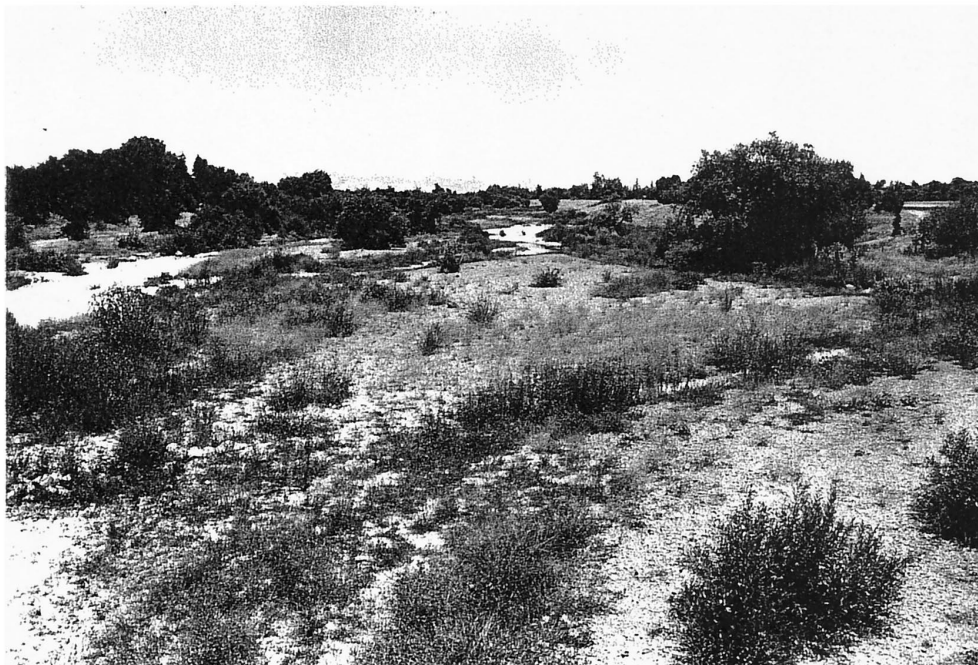
Field observations along Uvas Creek in July 1997 showed some scour at the toe of revetments along designed meander bends, but the revetments (and banks immediately up- and downstream) were not damaged. Uvas Creek simply abandoned the design channel and adopted a course through the constructed floodplain (Figure 5). Deposition occurred throughout the project reach, with revetments at the third meander bend (in a downstream direction) completely buried.

Figure 5. Photographs looking downstream from Santa Teresa Bridge at the channel of Uvas Creek. (a) in January 1996, about 2 months after construction of the channel reconstruction project, and (b) in June 1997, after the project had washed out. (1996 photograph courtesy of the City of Gilroy, 1997 photograph by Kondolf.)

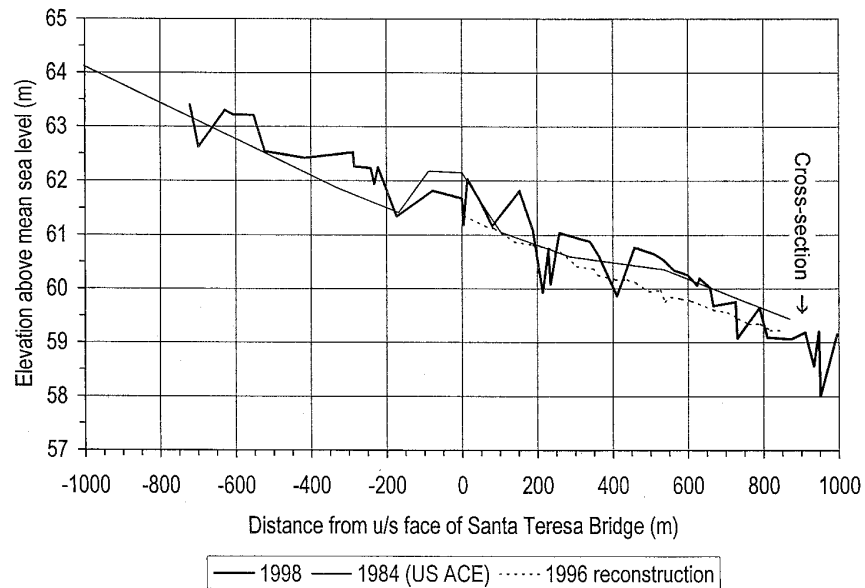
**Figure 6.** Longitudinal profile of Uvas Creek, near Santa Teresa Bridge. X axis is distance from bridge: negative values are distance upstream, positive values are downstream. The 1984 profile is from US ACE (1984), the 1998 profile is from Justine (1998), and the 1996 profile of the channel reconstruction project is taken from final AutoCAD construction drawing.

The longitudinal profile of the channel shows little differences in bed elevation between 1984 and 1998, although the 1984 profile (US ACE 1984) was not as detailed as our 1998 survey, so it was not capable of picking up the irregularities in the bed shown on the 1998 profile (Justine 1998) (Figure 6). The design channel averaged about 0.5 m lower than the surveyed bed elevation in 1984 and 1998. Channel gradient ranged between 0.17% and 0.3%. The cross section we surveyed about 900 m downstream of the Santa Teresa Road bridge shows the active channel was narrower in 1998 than in 1939 and indicated that the current channel is incised about 2 m below the remnants of the 1939 channel bed (Justine 1998) (Figure 7).

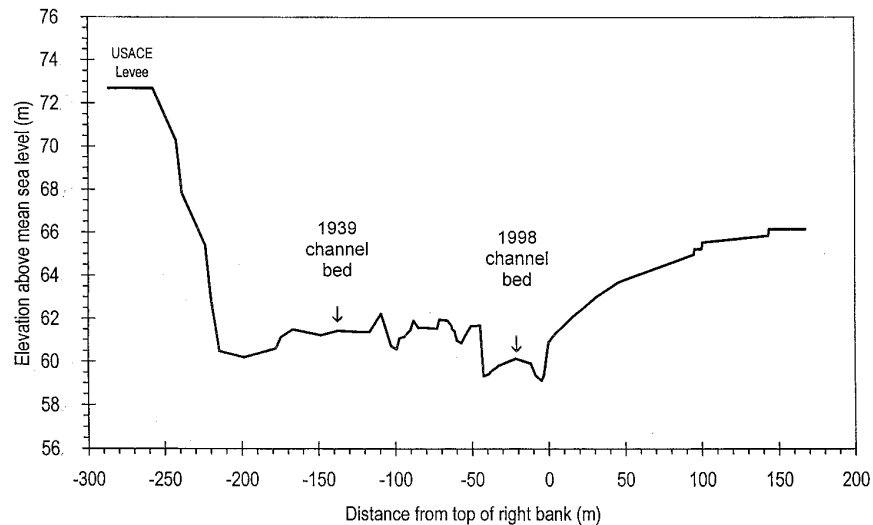
**Figure 7.** Cross-section surveyed in 1998 near the downstream end of the channel reconstruction project, 900 m downstream of Santa Teresa Bridge. About 2 m of incision since 1939 is inferred from comparison of sequential aerial photographs. Adapted from Justine (1998).

than indicated by our cross-section near the downstream end of the project reach (Figure 7), which may be attributable to the greater concentration of gravel mining upstream of the project reach.

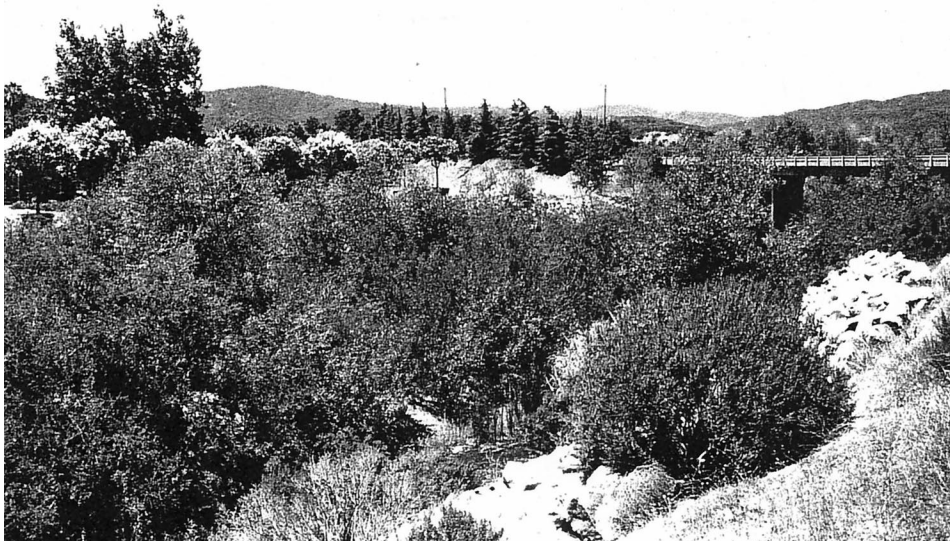
**Figure 9.** Photographs looking upstream towards the Hecker Pass Highway Bridge (formerly known as “Twin Bridges” crossing of Bodfish Mill Road). (a) in 1894, and (b) in June 1997. (1894 photograph is courtesy of Gilroy Historical Museum; 1997 photograph is by Kondolf.)

channel pattern with bare gravel bars in between the channels. In 1997 this same view showed Uvas Creek had incised about 6 m within a single channel and narrowed (Figure 9). This is considerably more incision

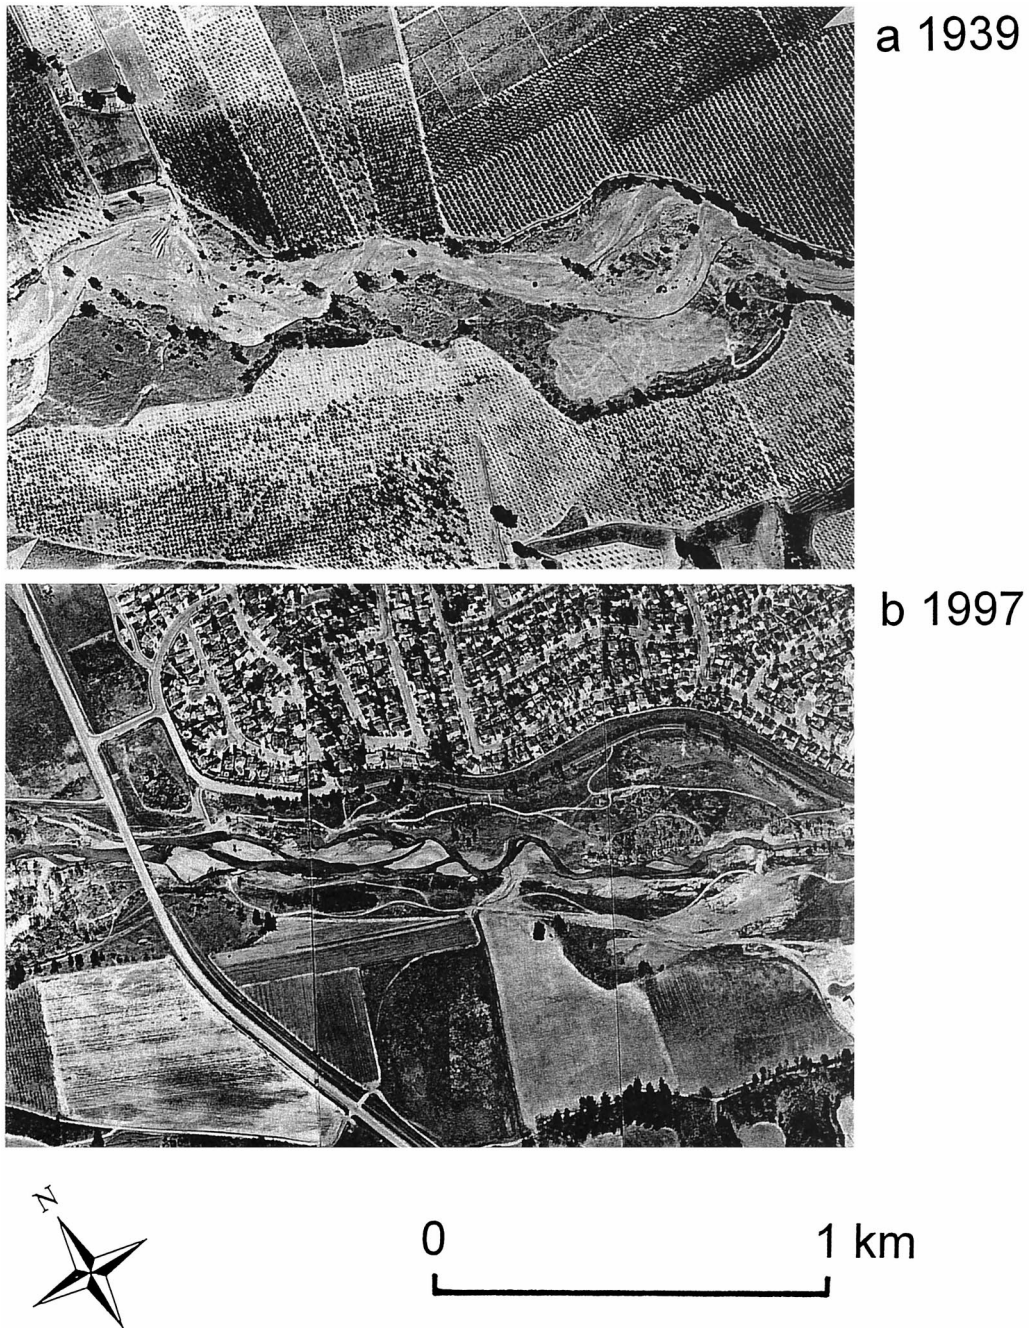
Figure 10. Aerial photographs of Uvas Creek below the present location of Santa Teresa Boulevard Bridge in 1939 and 1997.

In the project reach, the width of the active channel measured from aerial photographs decreased about 70% between 1939 and 1993. The 1939 aerial photographs show a broad, unvegetated, braided channel between well-defined escarpments (Figure 10). Comparing 1939 and 1956 aerial photographs of Uvas Creek shows that the dominant (or low-flow) channel changed location within the active channel zone, although the braided form and width of the active channel remained similar. By 1993, the channel had incised and mostly adopted a single thread. In the project
