# **VDOT Stormwater Management Maintenance Program**

**Hampton Roads District SWM Inventory and Inspection Manual**

# Hampton Roads District SWM Basins Inventory & Inspection Manual

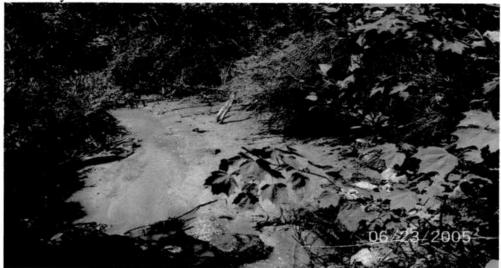
Sediment build-up in inlet due to conveyance channel instability

Q-in condition rates the overall condition of the discharge points into the basin and the adverse effects that may impair the performance of the SWB. Erosion or sediment build-up of the basin as the result of un-stabilized discharge points should be evaluated. This evaluates the result of Q-in stability or instability as found in the inlet area and/or floor of the basin. (see item #3)

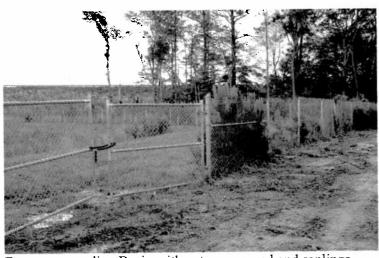
Fence surrounding Basin with gate unsecured and saplings growing in fence line

Fence rates the presence of a structurally sound fence with a locked gate. This parameter should be evaluated based on the physical location of the SWB to public access and site conditions.

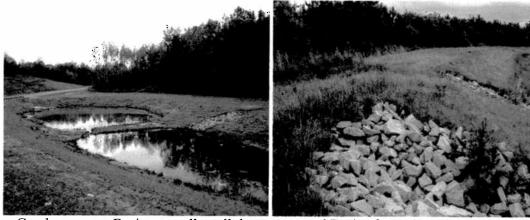
Good access to Basins as well as all the way around Basins for maintenance

Due to varying site conditions, access roads may not be easily identifiable. However, if an area surrounding the SWB meets the above criteria, then the access parameter has been satisfied. Other access considerations could be from county or local roads or private right-of-way when access is restricted by the construction of noise walls and chain-linked protective fences. The presence of roadway guardrail should not be taken in to consideration because these items can be removed and reset after the maintenance operation.

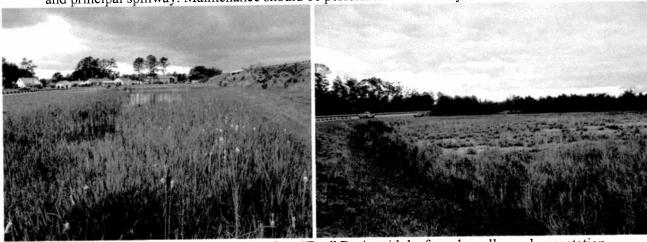
Shallow "Wet" basin with herbaceous vegetation "Dry" Basin with leafy and small woody vegetation

SWB-Vegetation rates the overall (live) vegetative condition of the SWB related to the type, size, percent cover, soils, and SWB type. Some facilities by design may lack an abundance of vegetation. Basins with a permanent pool normally have vegetation along the fringe and in water depths of less than 6 inches. Basins with no permanent pool should have vegetation throughout the basin.

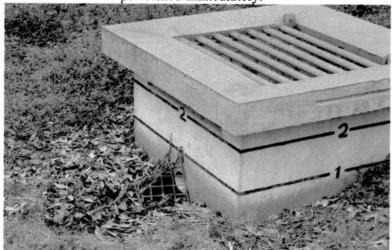
Trash rack clear and functional and structurally sound

- **0** No trashrack exists.
- 1 Riser-Trashrack is free of any woody/leafy and garbage debris. Trashrack is undamaged and functioning properly.
- Riser-Trashrack is blocked approximately 0 to 25% with woody/leafy and garbage. Trashrack has *minor* damage, but functioning properly.
- Riser-Trashrack is blocked approximately 26 to 50% with woody/leafy and garbage debris. Trashrack has *moderate* damage and only partly functioning. Maintenance should be scheduled.
