BENDWAY WEIRS AND SOIL BIOENGINEERING FOR CALIFORNIA BURN DUMP REMEDIATION

This paper describes the first Bendway Weir project to be implemented in California. The Bendway Weir concept was developed by the Waterways Experiment Station (WES) in 1988 as a solution to a number of environmental and navigational problems caused by river bends (bendways) along two reaches of the Mississippi River. Performance there has been impressive. Since 1992, Bendway Weirs have been used on various sized rivers and streams in several areas of the country. The Bendway Weir and Longitudinal Peaked Stone Toe Protection (LPSTP) system was chosen for Buckeye Creek because of its proven efficacy in similar situations. John McCullah, erosion control consultant, David Derrick, hydraulic engineer, and Doug Hanford, soil bioengineering contractor, designed the streambank stabilization and erosion control components of this project.

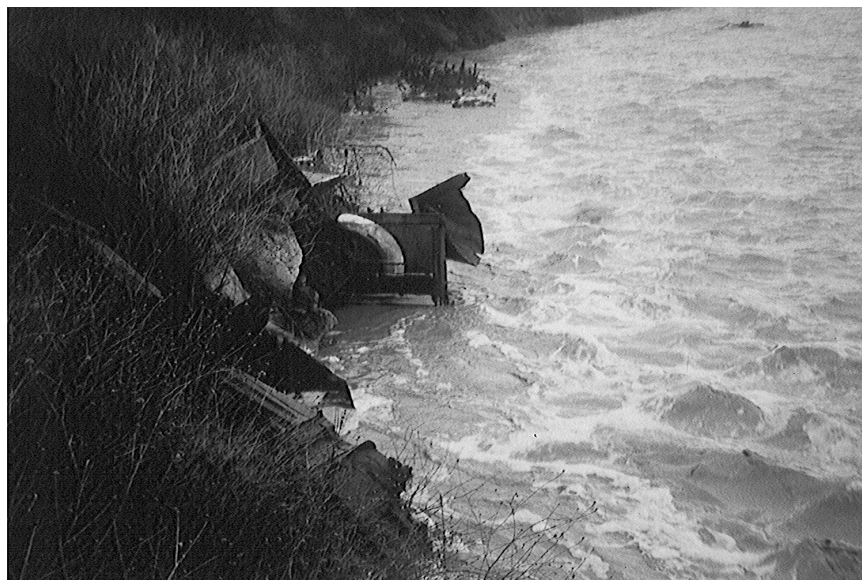
Figure 1. Erosion on the banks of Buckeye Creek was exposing waste and burn ash at the Dunnigan Burn Dump.

In recent years, streambank erosion exposed the waste and burn ash at the Dunnigan Burn Dump. In one winter alone, 1997/98, the accelerated erosion resulted in approximately 7 to 10 meters (20-30 feet) of lateral bank erosion which allowed the toxic waste to be washed into Buckeye Creek. The Yolo County Public Works Department requested the assistance of the CIWMB to manage the cleanup and remediation of the site. Subsequently, CIWMB engineers developed plans and specifications for the remediation. The remediation plans involved: (1) the removal of exposed waste from the landfill, streambank, and creek channel; (2) regrading the streambanks to the desired slope; (3) capping the areas of exposed waste; (4) constructing deflectors to

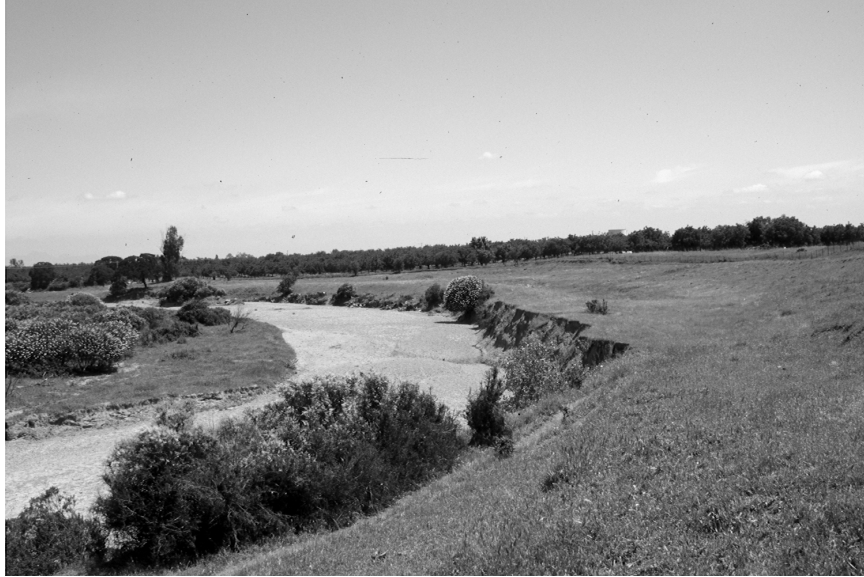
Figure 4. Buckeye Creek, before Bendway Weirs.

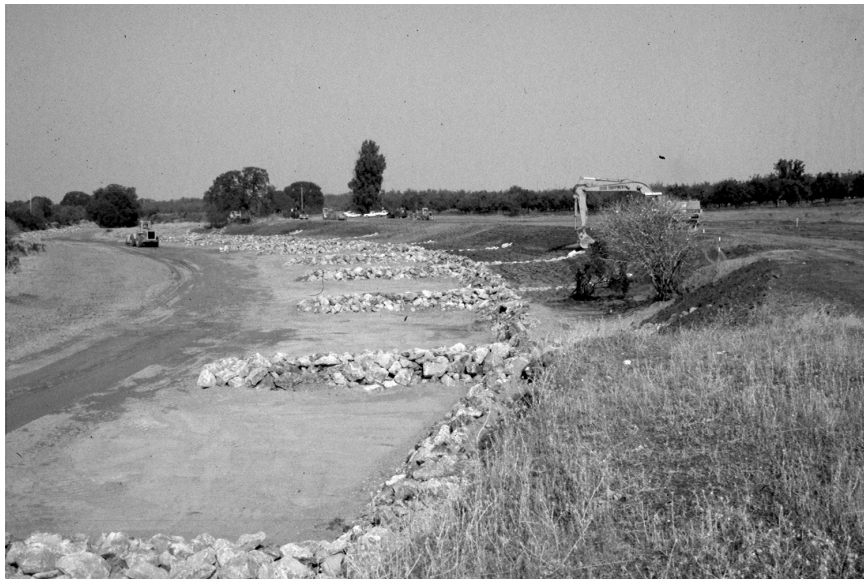
Figure 5. Bendway Weirs, during completion of the keyways landward of the LPSTP.

Thirteen Bendway Weirs were constructed at locations and angles designated on the plans using careful onsite analysis. The onsite lay out, utilizing the advice of a Bendway Weir expert, is necessary because they have tremendous potential to affect stream processes and direction. The most important weirs are the first two or three - where the flows enter the weir field and are thereby "captured". Also significant is the angle and length of the exit weir because it directs the flow downstream. The Bendway Weirs were designed between 12-17 meters (35-50 feet) long (from the LPSTP out into the stream) and angled 10-20 degrees upstream from their radii. Each weir was keyed into the bank to ensure the stream does not migrate or scour behind the structures. The keys were of various length such that they extended through and landward of the LPSTP, into the bank until the crest of the key was 4 meters above the streambed, and the keyways were a uniform 1 meter thick.

smoothed before placement of the stone. The weirs were placed approximately 20-30 meters apart and angled upstream. While the loader facilitated rapid construction of the weirs, the excavator was necessary to excavate the keyways and place the keystones. As an additional precaution the LPSTP was extended for almost 100 meters above the first weir and 40 meters below the last downstream weir (Weir 13). Another precaution was taken to ensure the opposite bank was protected: a 150-meter long LPSTP was built along the left descending bank. This LPSTP was also keyed into the bank at 35-meter intervals. The upper end of the LPSTPs were keyed into the point bars by digging trenches 1.2 meters wide by 1.2 meters deep and filling those with sufficient stone to ensure the flows do not go around the LPSTP.

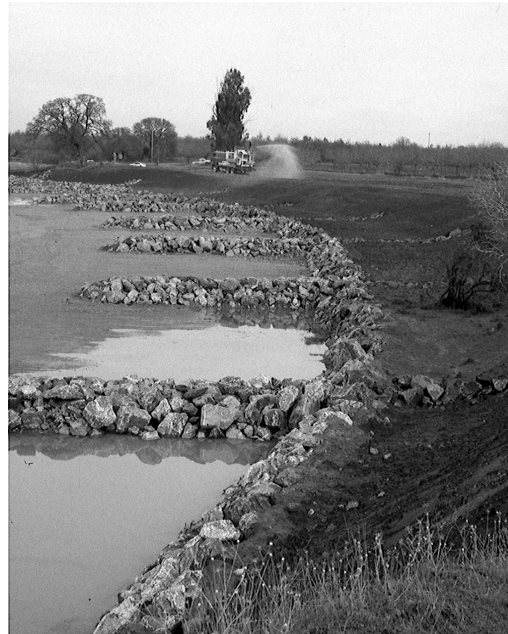
The area was hydroseeded with a native grass blend.

<u>Species</u>	<u>PLS (lb./acre)</u>	<u>% of Mix</u>
Hordeum californica sp. californica	13	20%
Stipa pulchra (Purple Needlegrass)	9.8	15%
Elymus glaucus (Blue Wildrye) var. Anderson	9.8	15%
Bromus carinatus (California brome)	9.8	15%
Lotus purshianus	6.5	10%
Mellica californica (California Mellic)	6.5	10%
Vulpia microstachys (Six Weeks Fescue)	6.5	10%
Poa secunda Secunda	<u>3.1</u>	<u>5%</u>
Total	65 #	100%

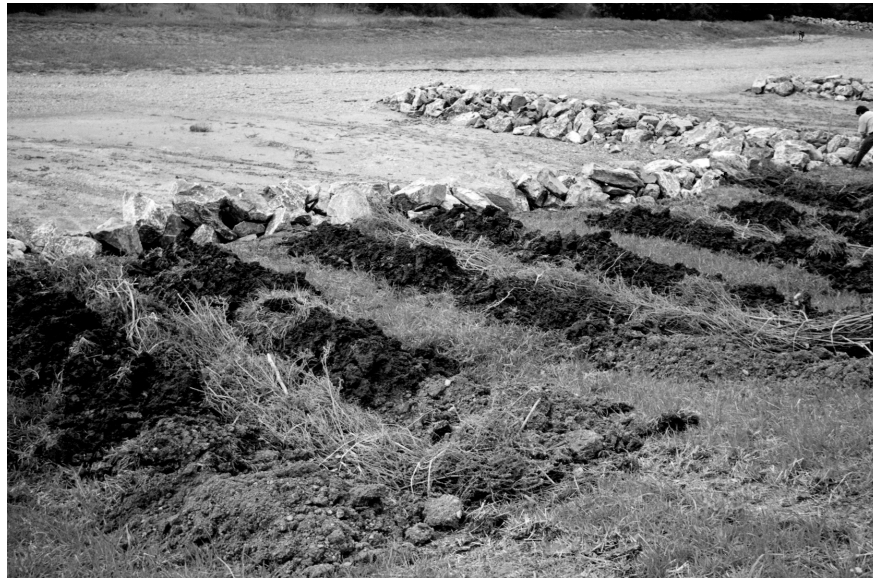
Figure 7. Composite Brush Siltation Weirs (CBSW's) were installed on the bench landward of the LPSTP in order to reduce overbank flow velocities and encourage siltation and natural revegetation.

Brush trimmings were cut with chain saws and stacked alternating the butt ends of the brush in both directions. The stacks were tightly bundled and secured with twine made of natural sisal. The finished bundles were approximately 2.6 meters (8 feet) long and 0.5-0.6 meters (18 inches-2 feet) in diameter. Trenches were dug into the graded bench area on the landward side of the LPSTP, perpendicular to the stream

The composite brush bundles were then installed into these trenches with the lower half of the bundle buried and secured in place with pole cuttings and stakes cut from 2 x 4's.

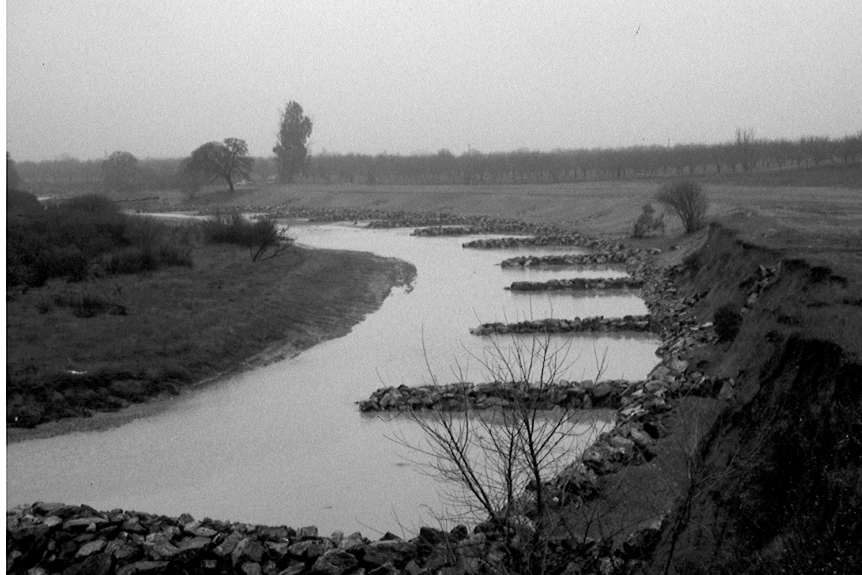
Figure 8. Even the highest flows in the winter after construction did not overtop the Bendway Weirs. Note the LPSTP is protecting the high bank in the foreground, allowing it to naturally repose.
